KBL

Service information

How to avoid equipment failures with preventive maintenance measures

Tower pureEnergy

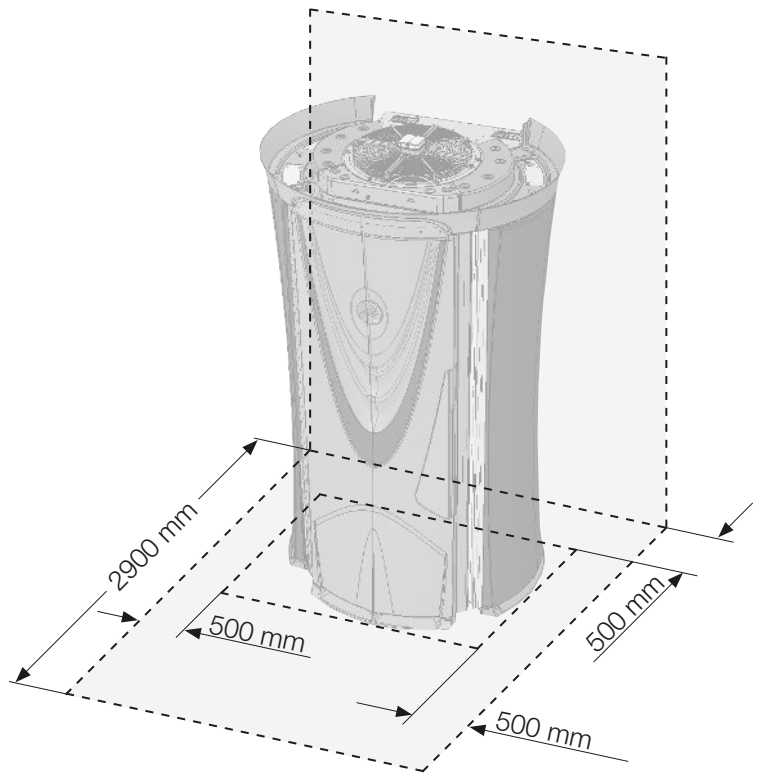
- Avoid in any case a change, obstruction or blockage of the air inflow and outflow area to the tanning device or make any unauthorized changes to the tanning device. The manufacturer shall bear no liability for damage or injuries resulting from such actions.
- Comply with the ventilation information to avoid serious system malfunctions.
- Only use OEM spare parts of the same type! The use of other parts will void the manufacturer's warranty!
- Maintain the minimum distances from **rear wall** and **side walls**:

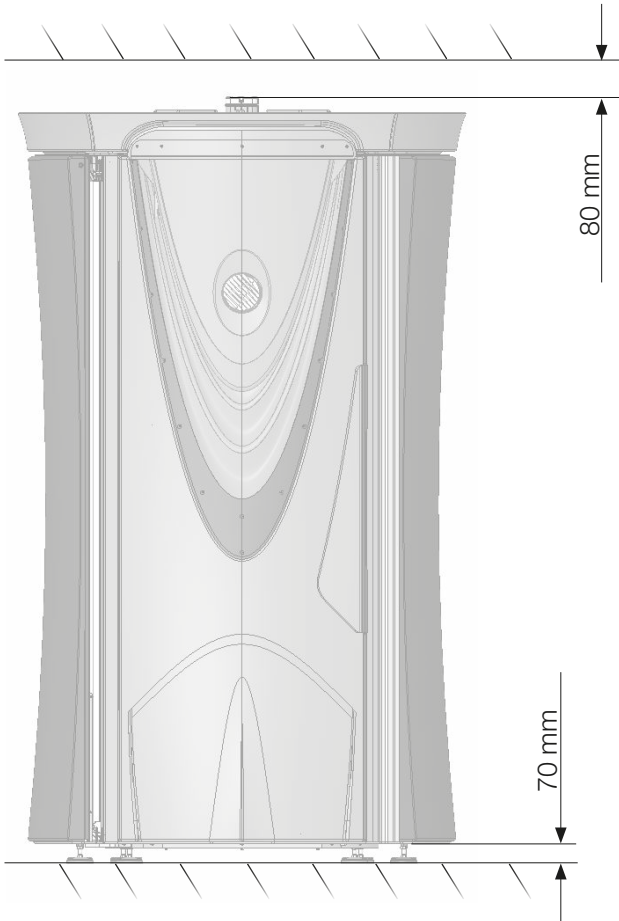
- Maintain the minimum distances from **ceiling** and **bottom**:

- Insufficient air supply leads to overheating. This can lead to damage the tanning device!

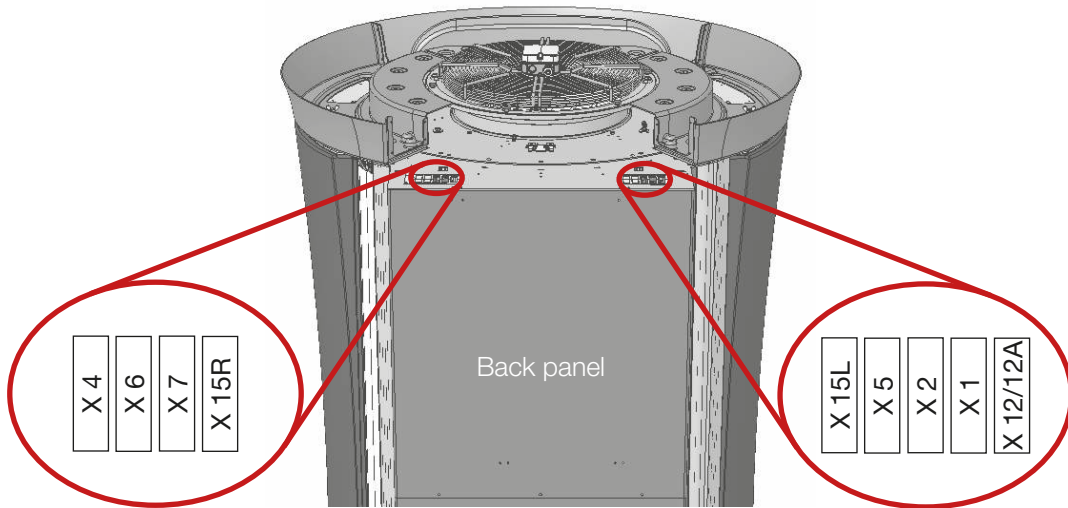
Positions from outside

4. Important positions: Connections at the top of the rear wall - left and right

Professional replacement of plug/socket is conducted from inside the tanning device. Under no circumstances pull the wire harness out of the socket from outside! This may cause a reduction of the contact quality and could lead to electrical overstress.

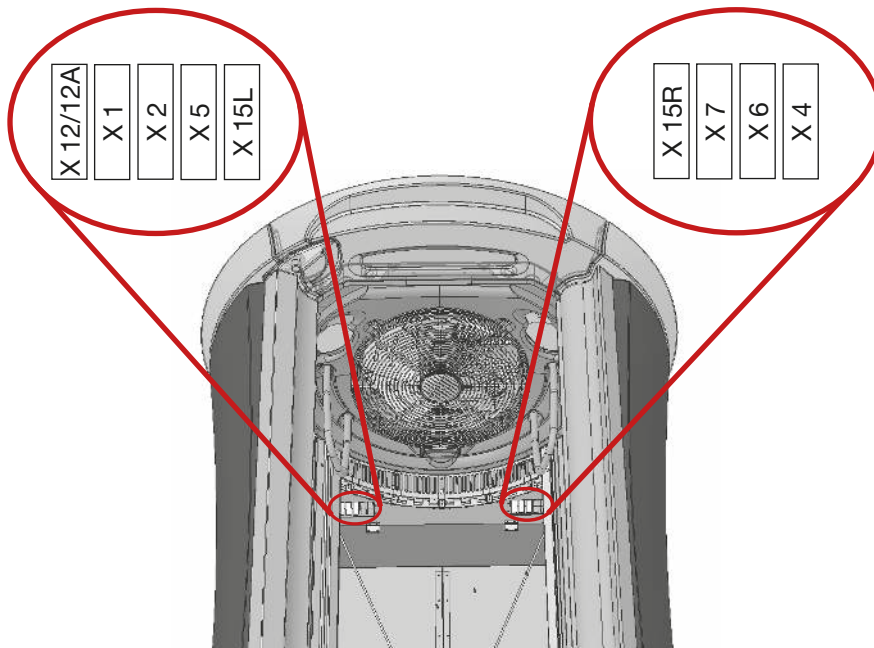
Positions from inside

Signs of electrical overstress - EOS

Check the plugs on signs of electrical overstress!

- **Discoloration**
- **Deformations**
- **Melting**
- **Blisters on the housing**

The affected components shall be replaced immediately! Use only OEM spare parts.

Only the following connectors shall be used:

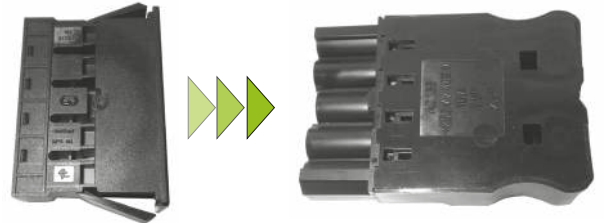
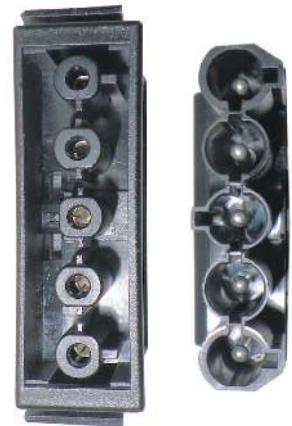
4.2 Check the connector and socket interior for signs of electrical overstress.

- Disconnect all connectors.

- If there are signs of electrical overstress, replace the affected connectors immediately!
- If the connecting cables show signs of electrical overstress, they should be shortened to the damaged part. If necessary, the cable harness must be replaced completely.

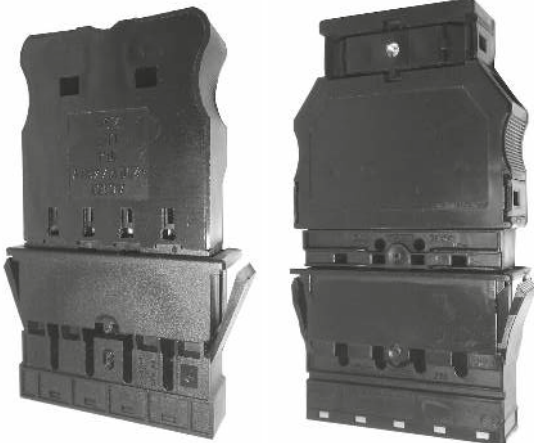
Depending on the year of manufacture, connectors from two different suppliers were installed at the factory.

- In the case of a defect all connectors must be replaced by WAGO connectors.
- Always replace the complete connector (plug and socket).

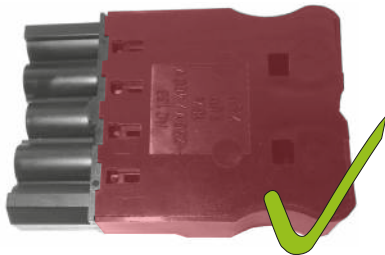
Never use the connectors without tension relief housing.

Attention
Improper
installation with
risk of electrical
shock!

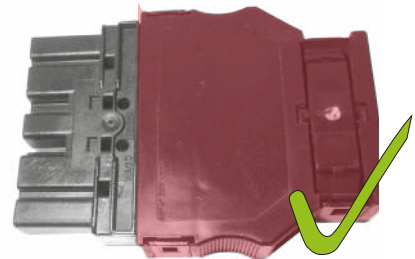
Attention
Improper installation
with risk of electrical
shock!

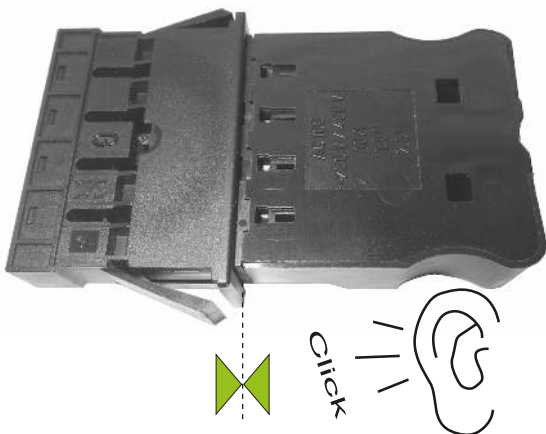
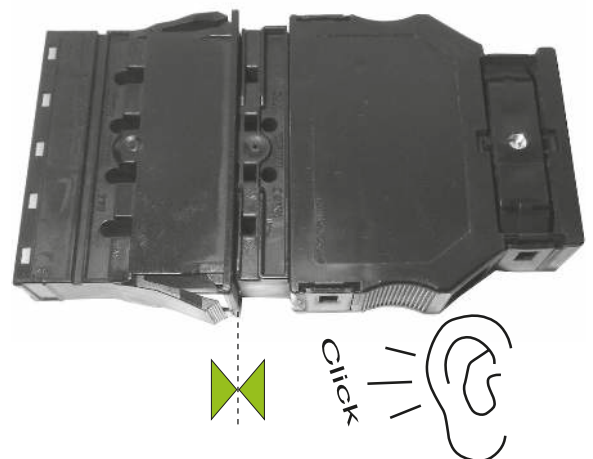
Please check that all connectors are plugged into the socket housing to the end stop.
There shall be no distance between the housing of the plug and the socket.

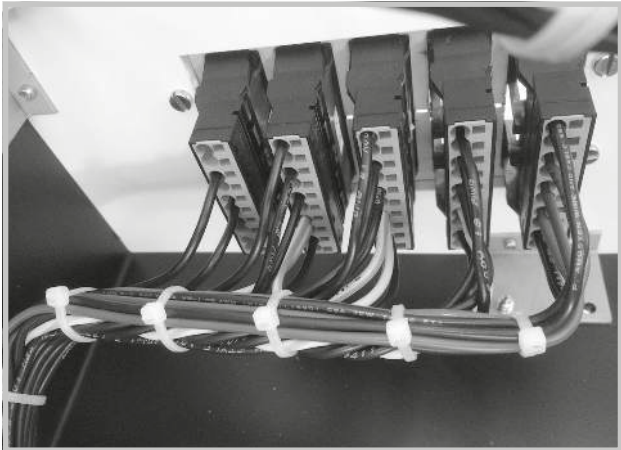
Perfect condition

- Lay the individual wires and the cable harness as shown in the figure.
- Use sufficient cable ties and position them as shown in the figure.
- Ensure good contact.

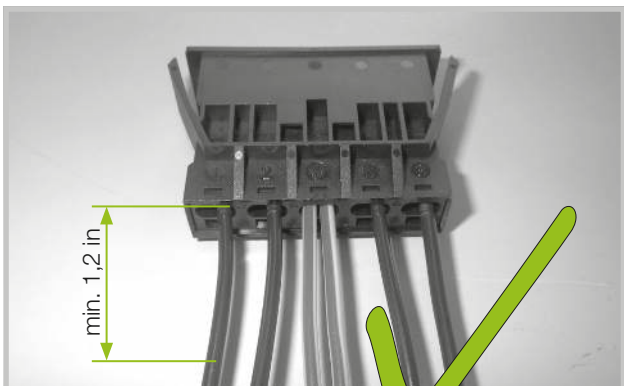
- Route the wires min. 1.2 inches vertically out of the connector plug.

Never attach cable ties directly next to the connector plug.

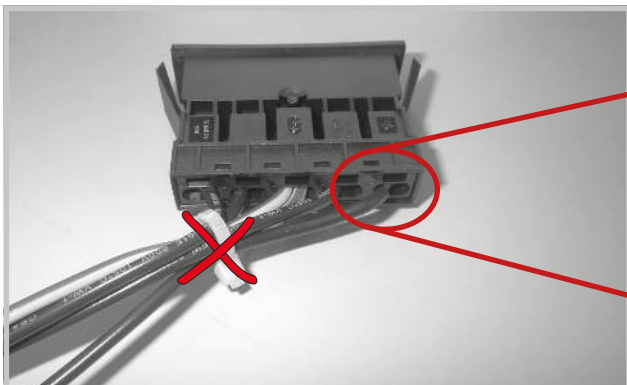
4.4 Cable tie applied too close -> bad contact

In order to operate this tanning device according to its intended use, each of the following defects must be remedied / corrected.

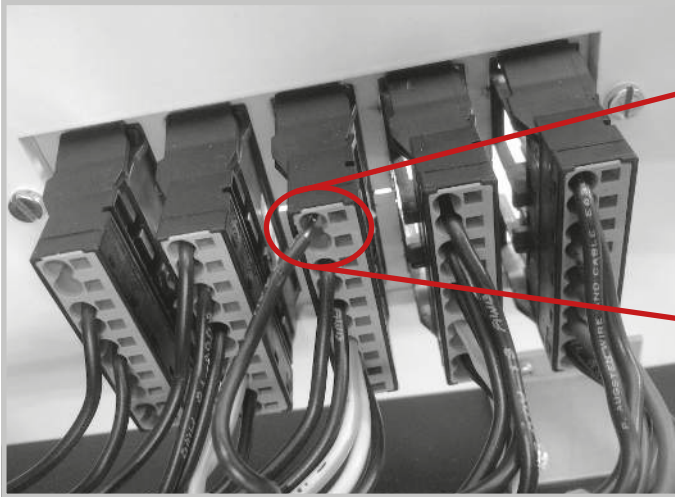
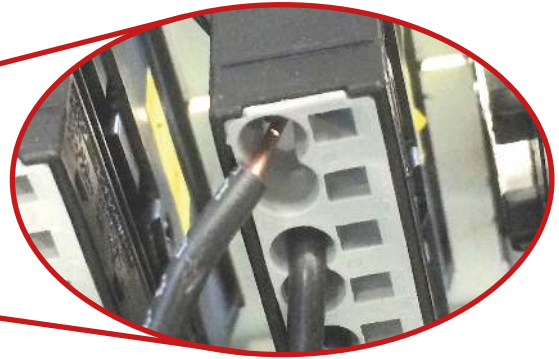
4.5 Bad or no contact

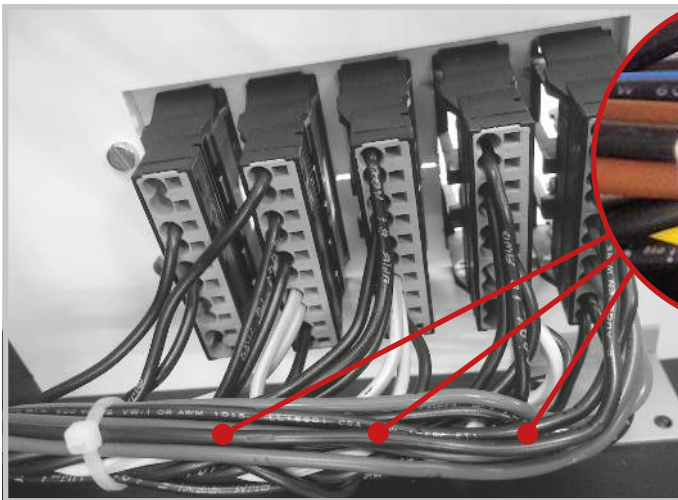
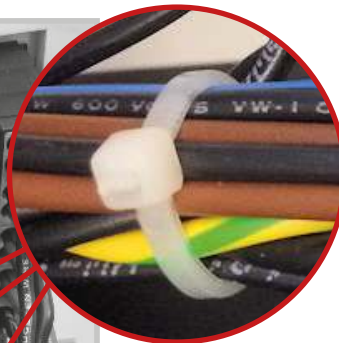
4.6 Missing cable ties

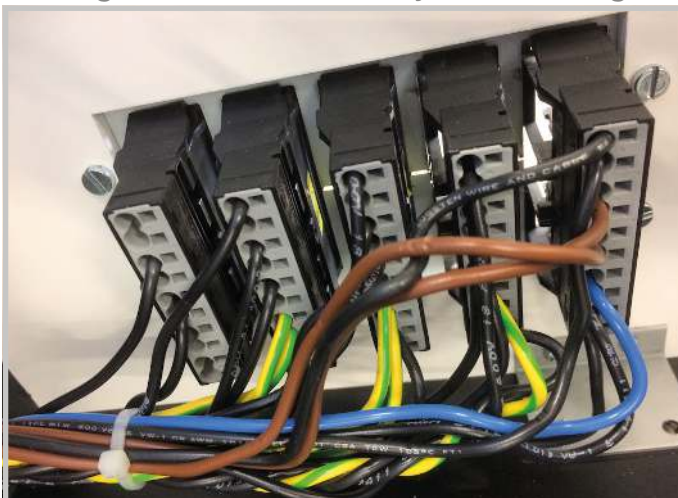
4.7 Missing cable ties and messy cable routing
